Manhole Inspection Summary

Manhole # S31S1_024MH

Location Address: **1349 Spelman Road**

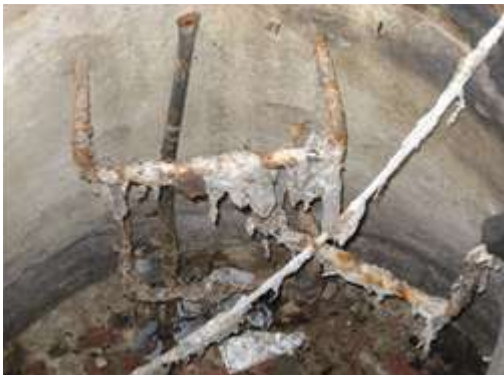
Steps Count: **3** Missing: **0** ☒ **Corroded**

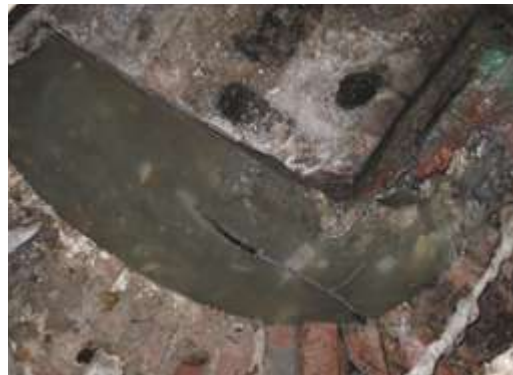
Defect 2

Condition: ☐ Sound ☐ Cracked ☐ Root Intrusion ☐ Deteriorated ☐ Leaks ☒ **Debris**

Channel

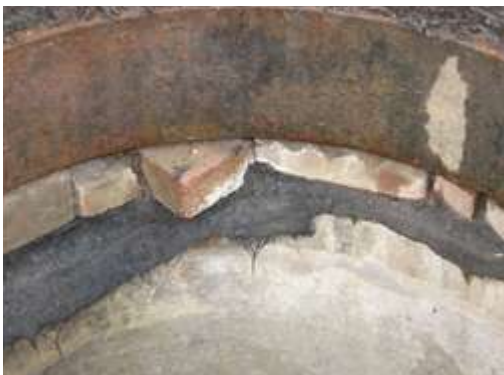
Defect 1

Condition: ☐ Sound ☐ Cracked ☐ Root Intrusion ☒ **Loose Brick** ☐ Deteriorated

Infiltration: ☐ None ☒ **Joint** ☐ Cracks ☐ Mortar ☐ Roots ☐ Wall

Infiltration

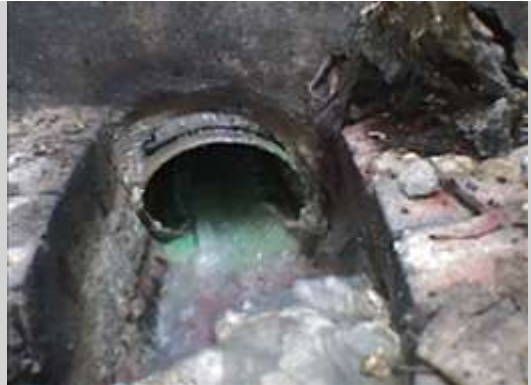
12 O'Clock Outflow

8 in. Circular Gravity Sewer
Pipe Out @ 12 O'Clock

Pipe Height: **8.4** (in.) Rod and Bar (Angled)
Pipe Material: **PVC** ☐ Pipe Lined
Invert Depth: **6.15** (ft.) Flow Characteristics: **Fast**
Deposits: ☒ None ☐ Mud ☐ Sludge ☐ Debris ☐ Grease
Silt Depth: (in.) Deposits Extent:
Infiltration: **None** Pipe Seal Cond: **Sound**

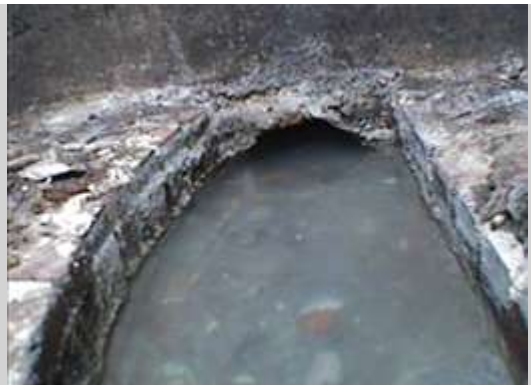
9 O'Clock Inflow

8 in. Circular Gravity Sewer
Pipe In @ 9 O'Clock

Pipe Height: **8.4** (in.) Rod and Bar (Angled)
Pipe Material: **Clay** ☐ Pipe Lined
Invert Depth: **6.15** (ft.) Flow Characteristics: **Slow**
Deposits: ☒ None ☐ Mud ☐ Sludge ☐ Debris ☐ Grease
Silt Depth: (in.) Deposits Extent:
Infiltration: **None** Pipe Seal Cond: **Sound**
